**GEOTECHNICAL INVESTIGATION
AND SLOPE STABILITY ASSESSMENT
PROPOSED SUBDIVISION - PHASE 1
PART OF 27-25-6-W3M
RM OF LOREBURN NO. 254, SASKATCHEWAN
PMEL FILE NO. 13147
NOVEMBER 6, 2017**

**PRAIRIE'S EDGE DEVELOPMENT CORPORATION
BOX 3370
HUMBOLDT, SASKATCHEWAN
S0K 2A0**

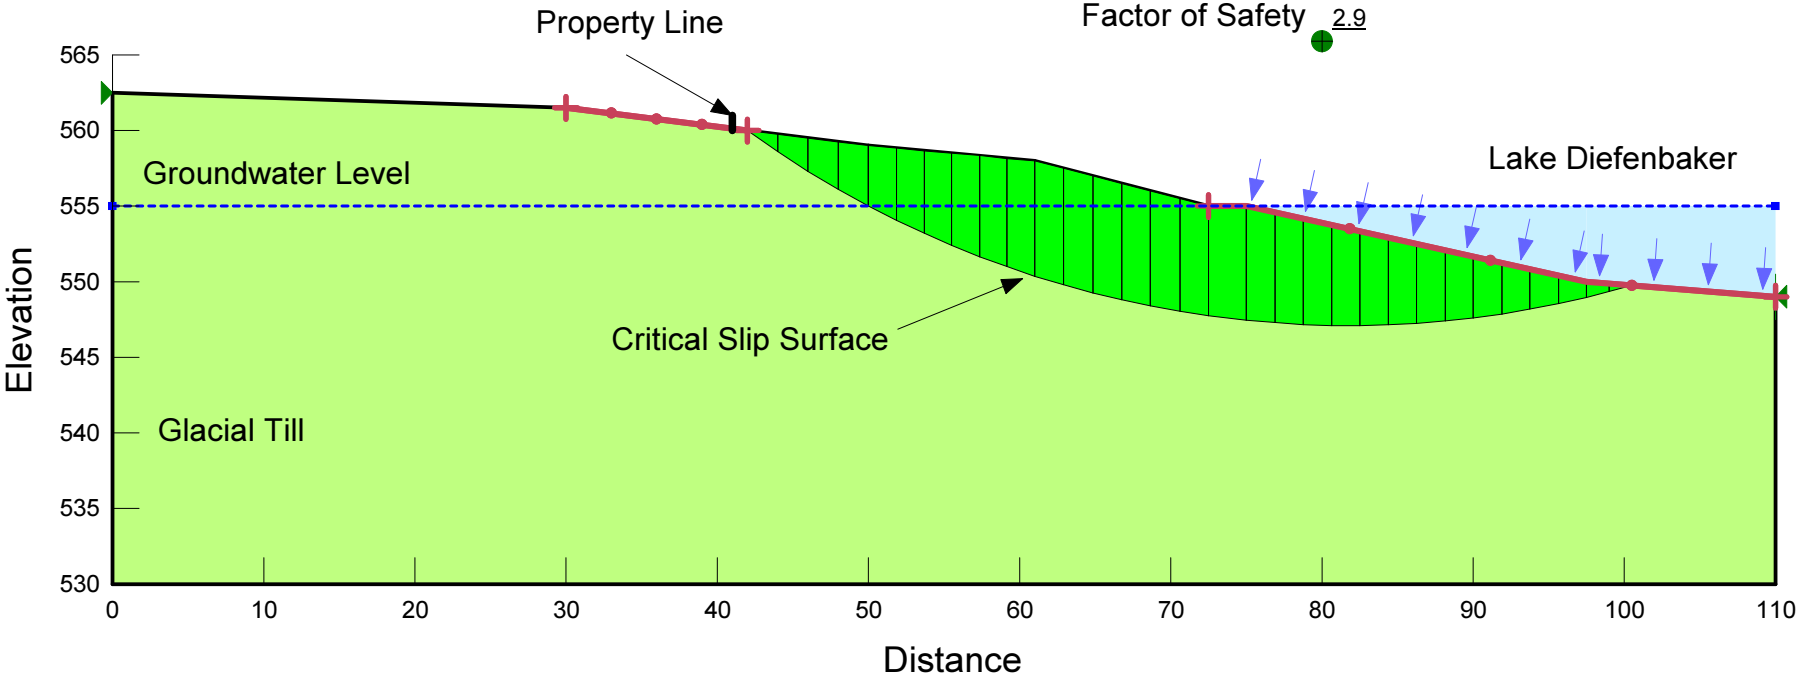
SECTION A-A'

Slope Section	Piezometric Condition	Calculated Factor of Safety	Drawing No.
A-A'	Inferred	2.9	C-1
B-B'	Inferred	2.8	C-2
C-C'	Inferred	2.9	C-3
B-B'	5 metre drop in lake water level	2.0	C-4

Based on the slope stability analysis, the Factor of Safety of the slope was at least 2.8, which exceeded the minimum recommended Factor of Safety of 1.5. As such, there is no recommended geotechnical building setback at this site provided any permanent structures are built within the proposed lot boundaries. A sudden drop in the lake level reduced the Factor of Safety by approximately 30 percent, but the Factor of Safety was still above 1.5 which indicates that the slope would remain stable.

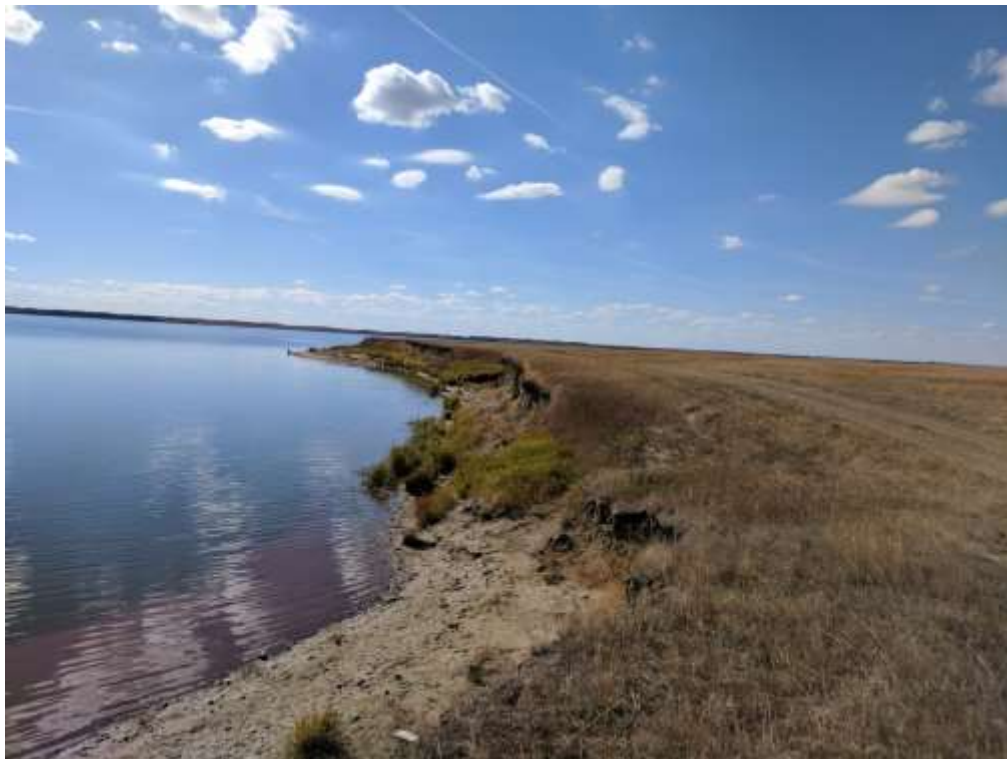
However, surficial slumping and erosion along the shoreline was evident during PMEL visual site review, particularly in the area of proposed Block 1, Lot Nos. 7 to 16, inclusive (refer to Drawing No. 13147-1A). As such, it is recommended that the shoreline be carefully monitored for signs of slumping/erosion and if it appears to be encroaching on the proposed lots, shoreline erosion protection measures should be implemented.

PHOTOGRAPH NO. 13147-02 Surficial slumping and erosion along shoreline. Approximately at west end of Phase I

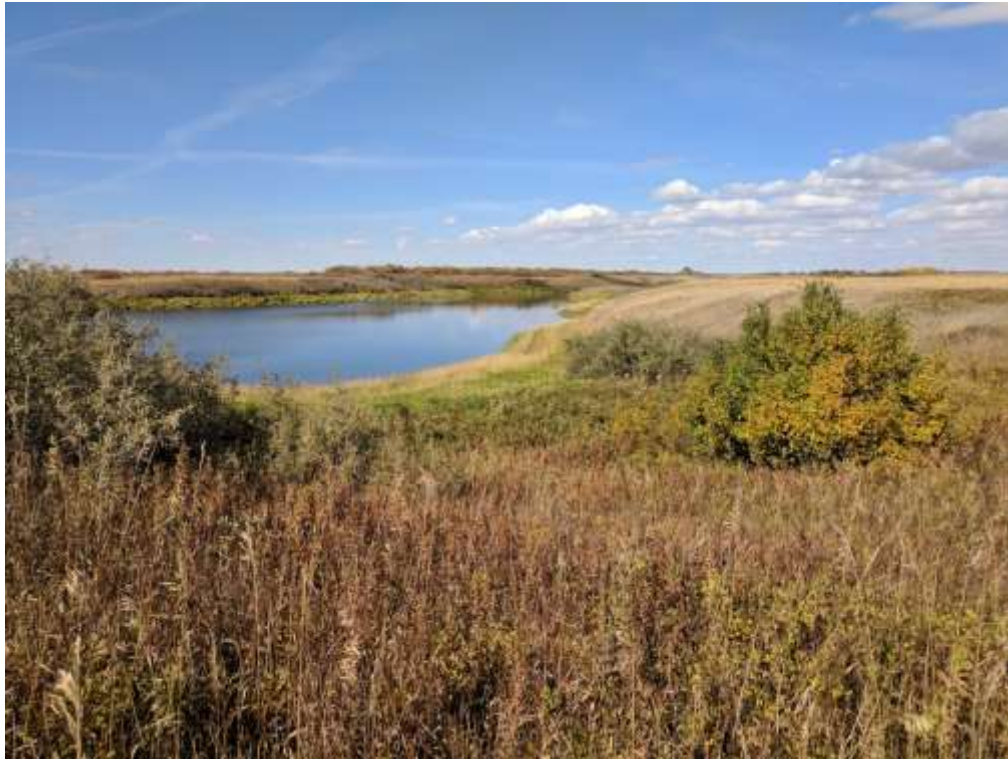
PHOTOGRAPH NO. 13147-03 Proposed Boat Launch area.

The Factor of Safety at the proposed Boat Launch location (Slope Section C-C') was 2.9. As such, the slope at this location was considered stable. It is recommended that the proposed Boat Launch grading plan is reviewed by PMEL once completed.
